Case Study:

Encapsulated O-Rings seal the deal for injection well in the Netherlands

Encapsulated O-Rings prove to be the ultimate sealing solution during gas injection for dutch operator.

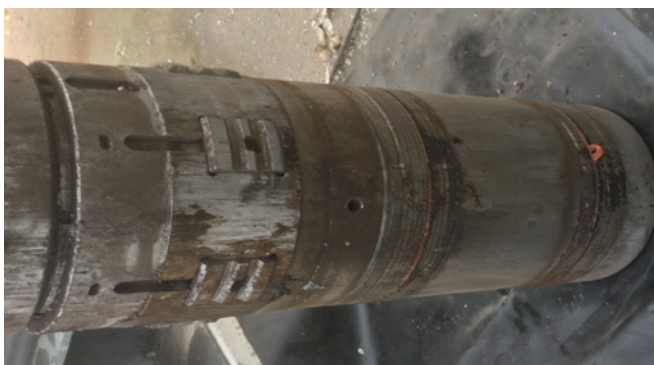
Injection sleeve retrieved from well with Encapsulated O-Rings still intact.

Throughout gas injection in Well A7B, TAQA's Encapsulated O-Rings successfully sealed the injection sleeves which showed no signs of leakage. The sleeves were later retrieved from the well through slickline intervention where they were cleaned and evidently showed that the O-Rings were still intact.

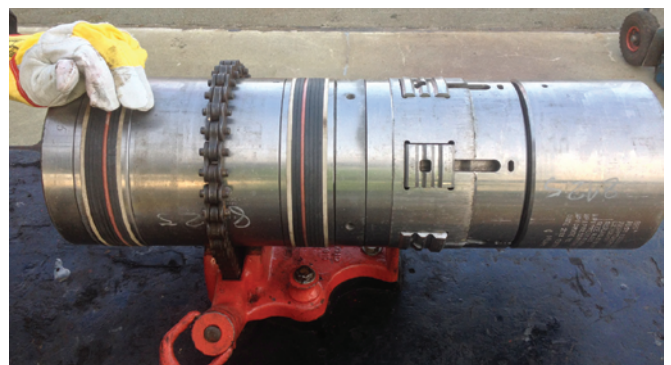
Injection sleeve and Encapsulated O-Rings cleaned after retrieval from the well.
