## Case Study:

# Remedial sand control solution outperforms standard screens

Successful deployment within a sliding sleeve in a high-rate gas well regains sand control integrity after Filtrex installation.

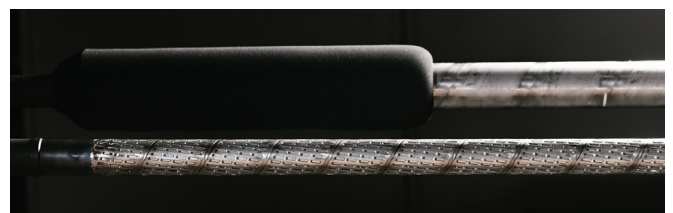
A 2.5m Filtrex was selected for this application for the operator to regain the sand control in existing completion. The deployment was performed with a slickline unit setting Filtrex across the Sliding Sleeve (SSD) withstanding high gas production rates.

TAQA introduced Filtrex to the operator which helped them to regain the well successfully. Filtrex is composed of compressible open cell matrix polymer (OCMP) designed to conform with the inside of the wellbore, filling the annular gap preventing any further sand inflow.
