Case Study:

SwellRight Side Pocket Mandrel Plug seals damaged mandrel bore for North Sea operator

SwellRight Side Pocket Mandrel Plug successfully isolates leaking side pocket mandrel for global operator in the North Sea.

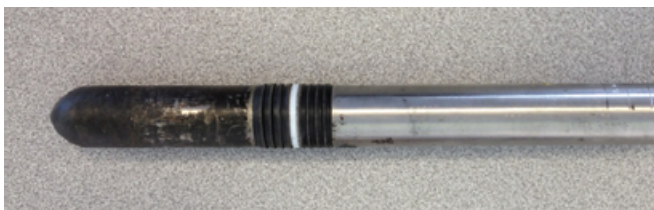
A major North Sea operator required a robust solution to seal a leaking gas lift mandrel and be able to withstand 5000psi. The chevron stack seals were damaged and replacement seals were no longer able to be sealed in the damaged mandrel bore.

Damaged Gas Lift Valve

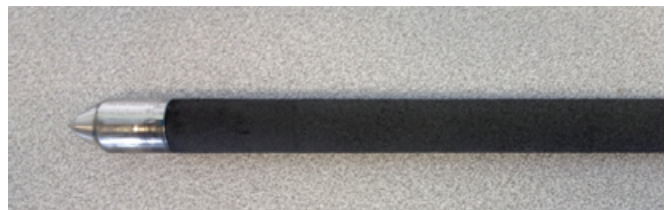
TAQA's SwellRight Side Pocket Mandrel Plug was deployed to seal the leaking mandrel bore, proving to be the ideal solution. A dummy valve was wrapped with water swellable

rubber capable of sealing in the leaking mandrel bore and holding 5000psi. The ease of installation and effectiveness of the product was extremely beneficial to the operator as it eliminated the need for intervention, pulling the entire completion to replace the leaking mandrel bore. Not only was it the simplest of solutions, it also reduced the risk factor and the cost of intervention.

SwellRight Side Pocket Mandrel Plug

TAQA's SwellRight Side Pocket Mandrel Plug successfully isolated the leaking side pocket mandrel, withstanding the required 5000psi, and eliminating the requirement for a workover.
